DOT/FAA/AR-02/121

Guidelines for Analysis, Testing, and Nondestructive Inspection of Impact- Damaged Composite Sandwich Structures

March 2003

Final Report

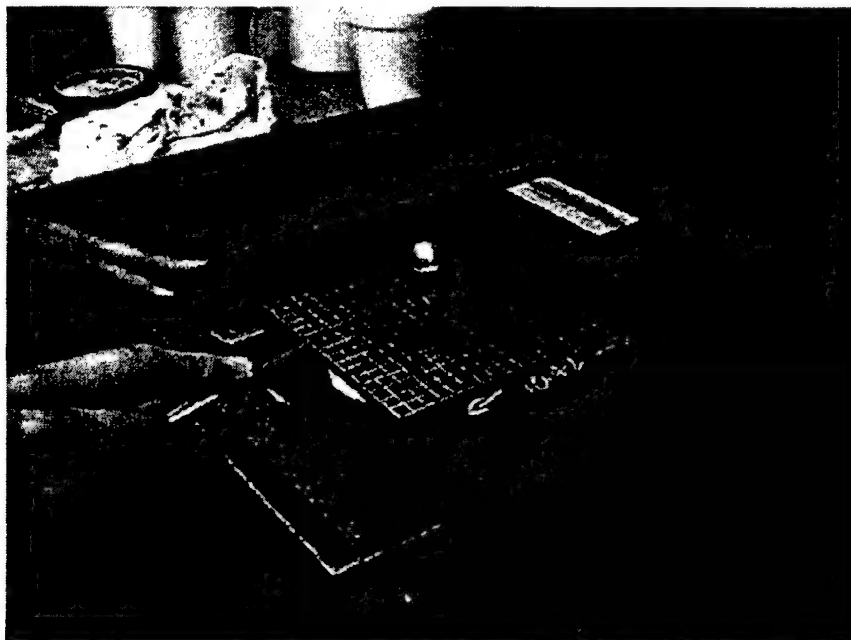
FIGURE 4-2. MANUAL IMPACT HAMMER (AIRBUS DESIGN)

In the acoustical tap testing, the characteristic resonant sound emanating from the tap test is analyzed by the human ear. The audible resonant sound will depend on the sandwich local impedance and tap mass/hammer characteristics. The damaged region is characterized by a dull (dead) sound, which can be attributed to the decreased participation of the higher frequency modes. The manual tap test hammer (Airbus design) is shown in figure 4-2.

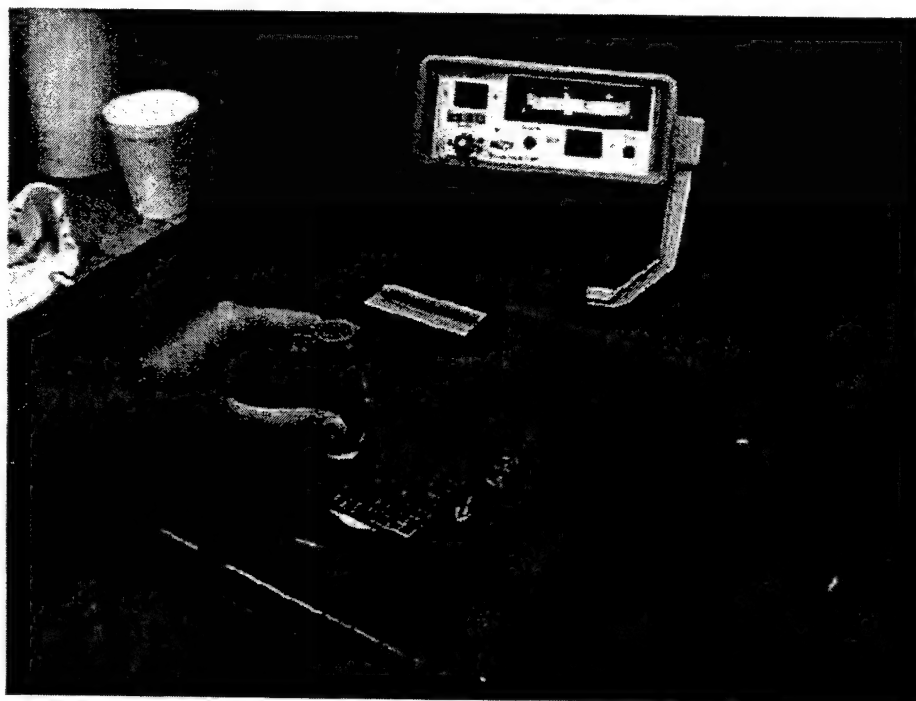
FIGURE 4-3. V-95 BOND TESTER USED FOR MECHANICAL IMPEDANCE ANALYSIS
